BUREAU OF SHIPS GROUP TECHNICAL INSPECTION REPORT

① OPERATION CROSSROADS,
U.S.S. FALLON (APA81)
TEST ABLE [U].

OPERATION CROSSROADS

USS FALLON (APA81)

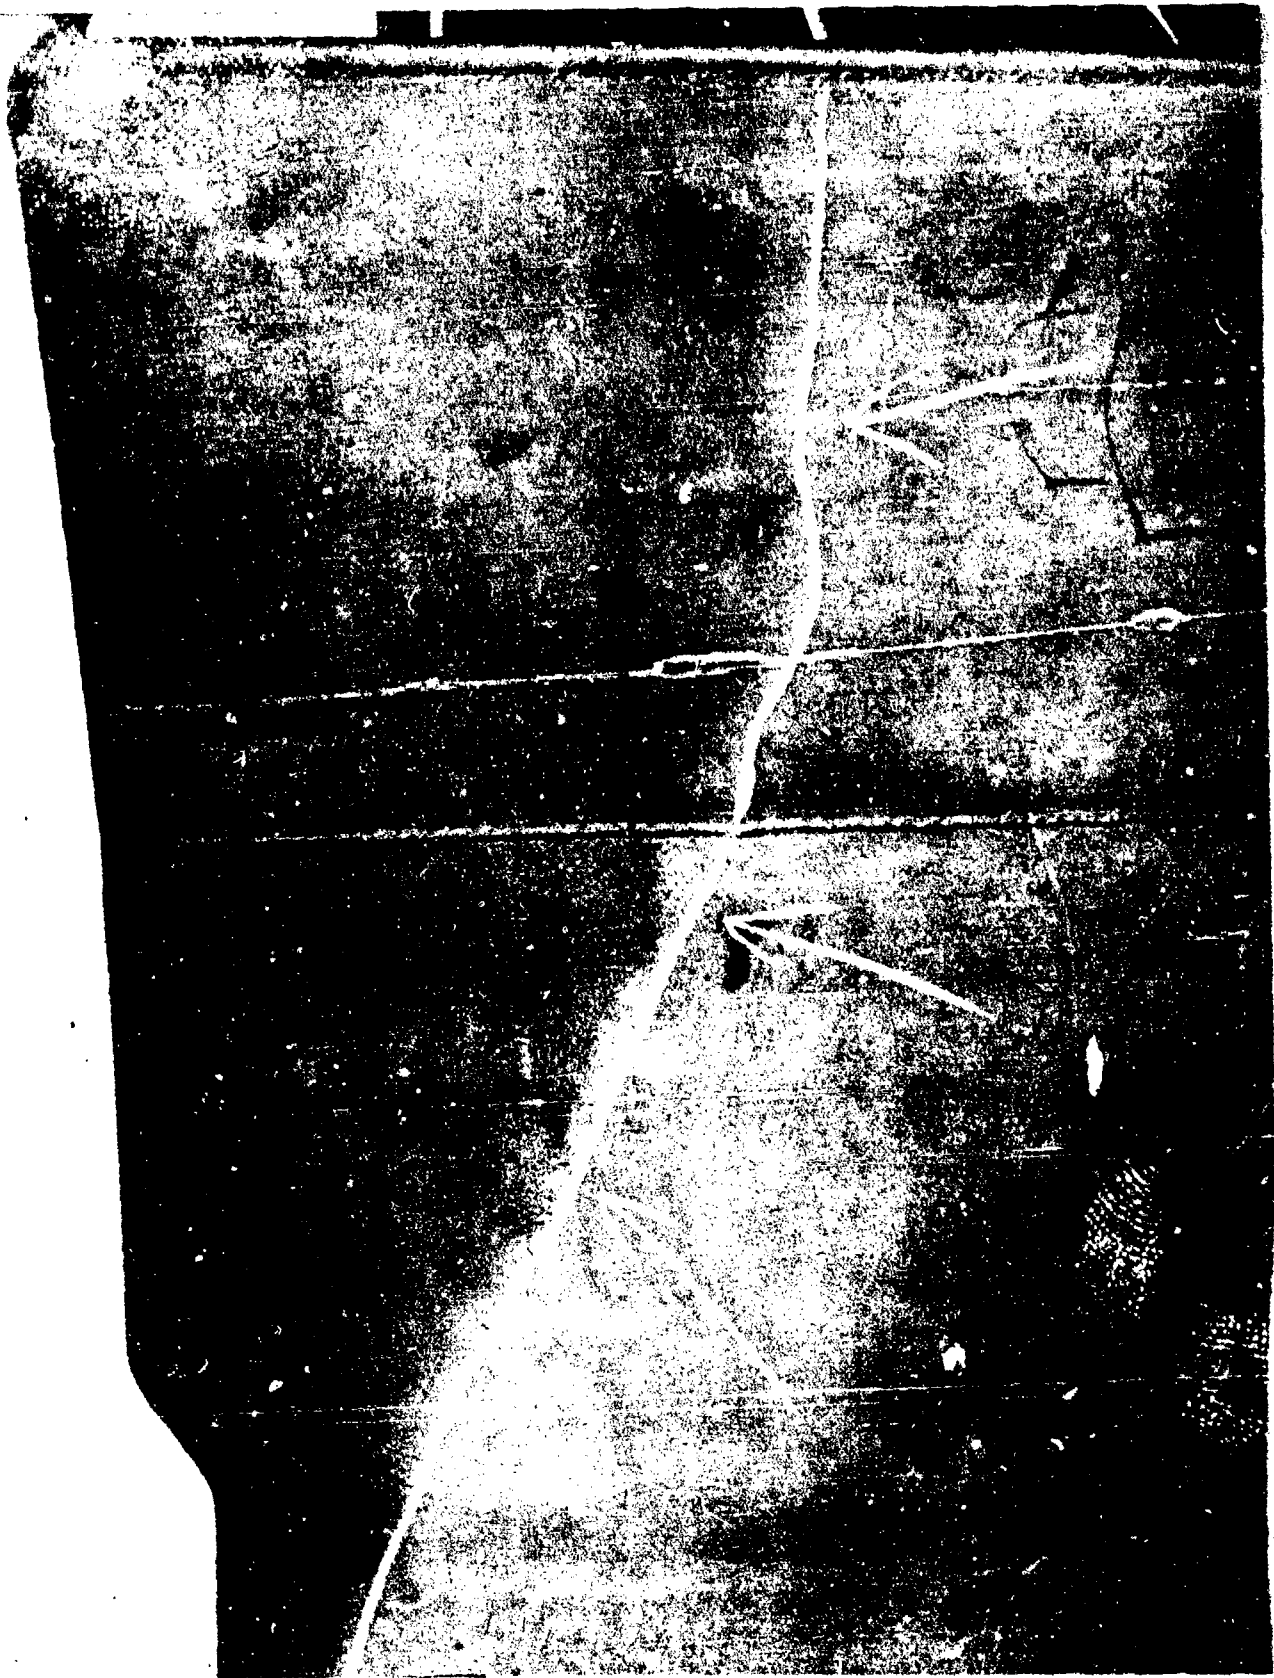
AA-CR-65-1819-12. Scorched paint on inside of gun bulwark, top of house, port.

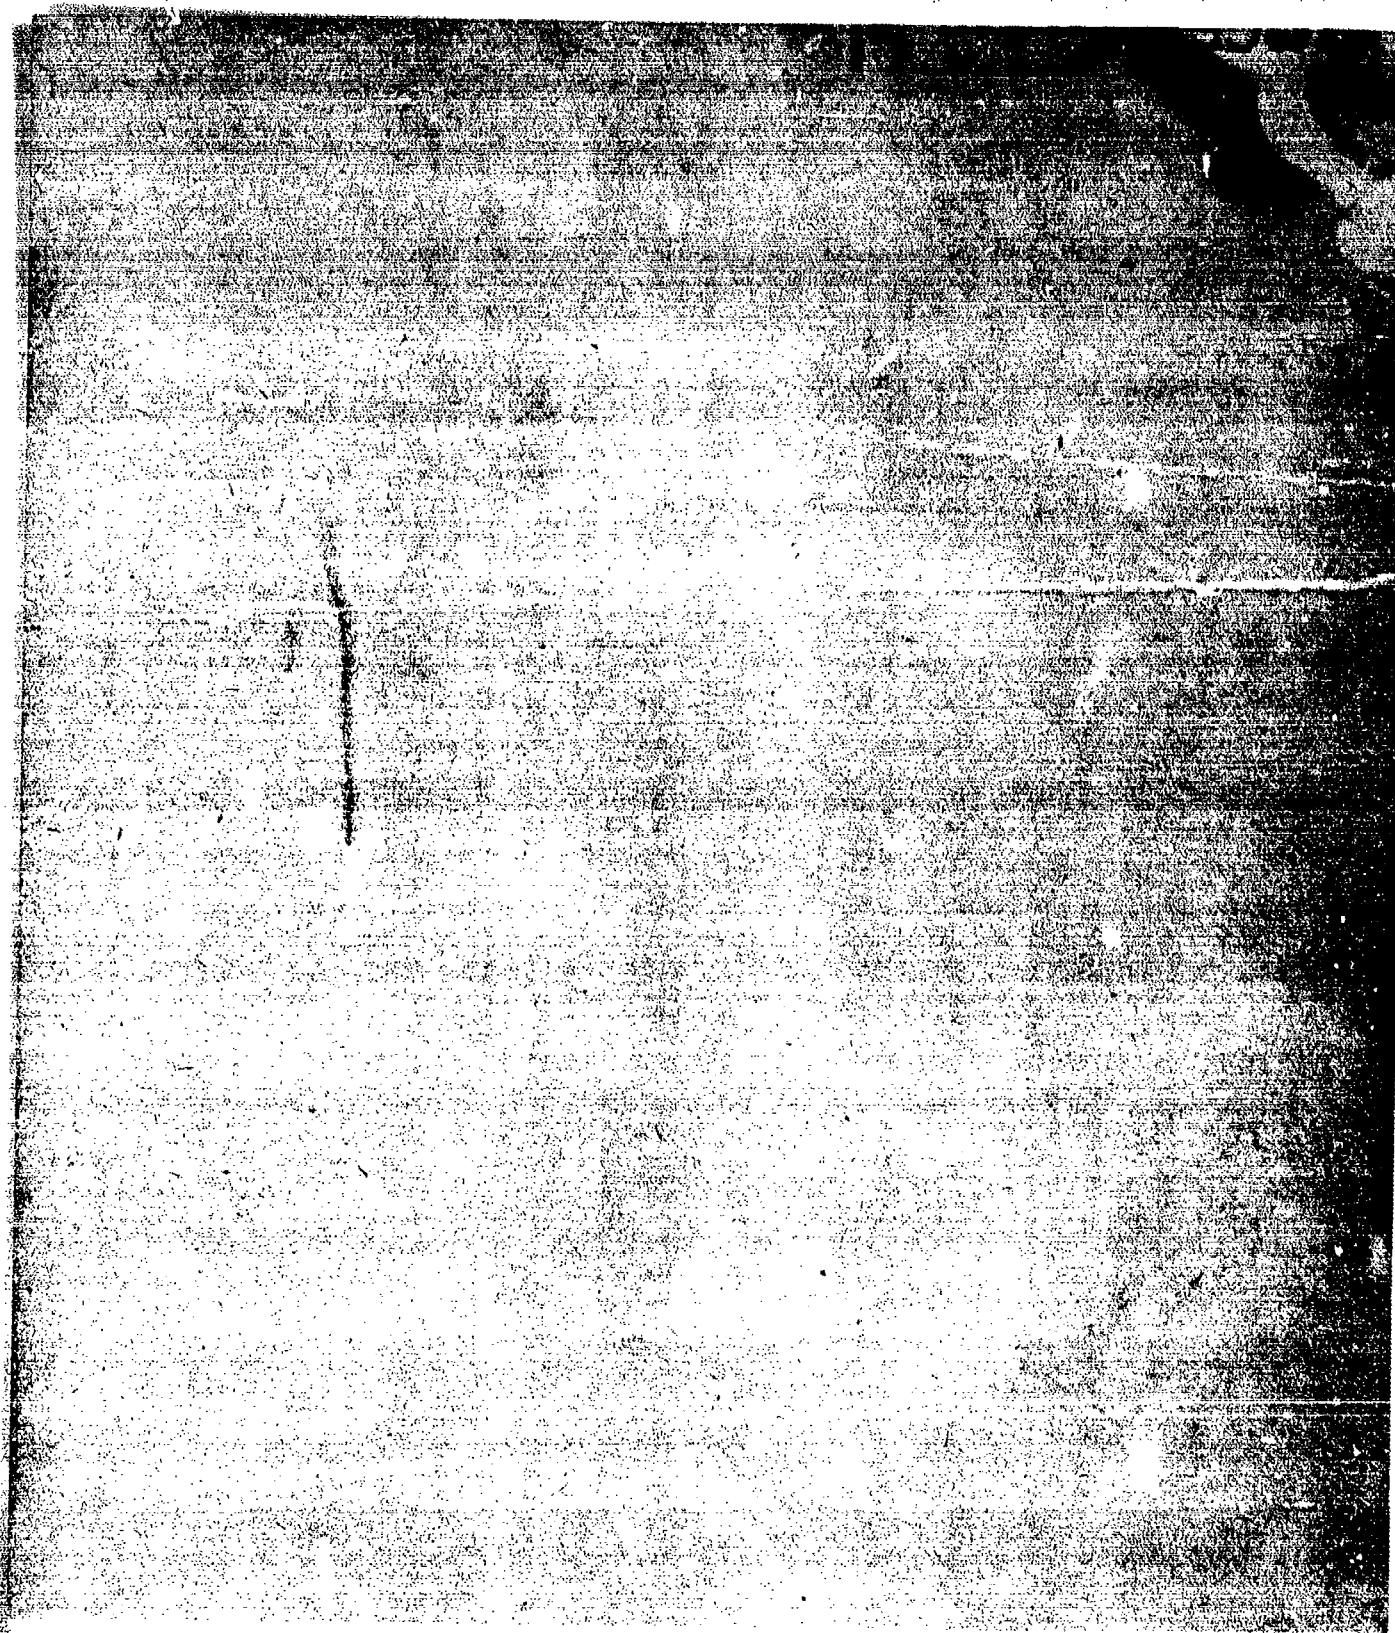
AA-CR-65-1848-10. Imprint of type-written sheet on deck house bulk-head, on upper deck, frame 99, port.
